Flashjet® Mobile Manipulator Development Project

Project Sponsor: CNO N45
Project Lead: NAVAIR Depot Jacksonville
Prime Contractor: Flash Tech, Inc.

Phase III Demonstration Final Report

July 14th, 2003

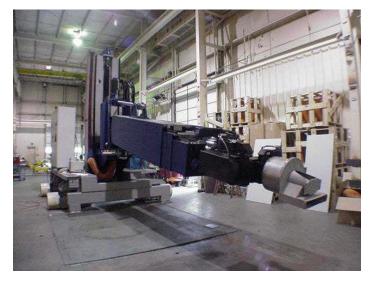
Plate 2: Phase I Mobile Manipulator

Key features of the mobile manipulator are:

Cart Control: Drives cart through a hand held pendant at rear end of cart. Cart has four sets of wheels and is driven by hydraulics through two wheel sets. Opposite wheel sets are idlers. Due to the unique design, cart is capable of being driven in any direction. Wheel sets can be extended to move and retracted to establish robot control over a sturdy three-point base.

Robot Axis & Range of motion: 1st axis: Boom rotate -45 to +45

2^{nd} axis: Boom pivot -15 to +60

3rd axis: Boom extend to 27 feet

Flashjet® Process Control: Windows Driven System w/remote control console providing full status, interlock and control of support systems as well as robot control and program review features. Laser stand-off distance sensors provide teach and auto surface tracking capability. Color vision sensing system provides auto-selective strip capability. IR scanning system provides surface temperature monitoring, control and track history.

Subsequently, PaR systems was given approval to design and build the manipulator. (See Plate 2 to for pictures of Mobile Manipulator with design features description.) This resulted in a successful demonstration of the new manipulator (with mock-up of flashjet head) using a full-scale P-3 model of a fuselage and wing section on August 7th, 2001. During the demonstration safety features and interlocks of the mobile system were fully demonstrated. Both project manager and the Boeing Company (Prime Contractor) witnessed this demonstration. A video of the demonstration effort is available for review.

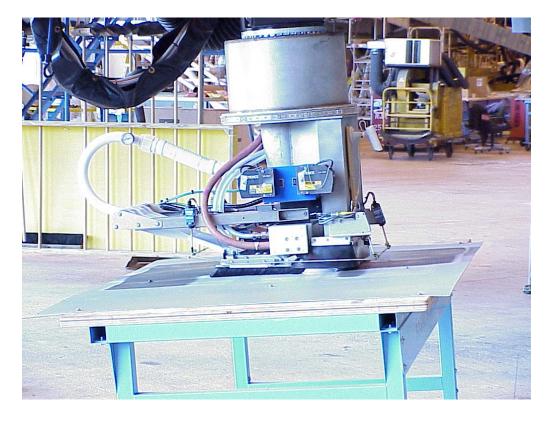
Plate 13: Flashjet Strip of Test Panels

Note uniformity of strip down to base metal. This result was consistent during all demonstrations of test panels.

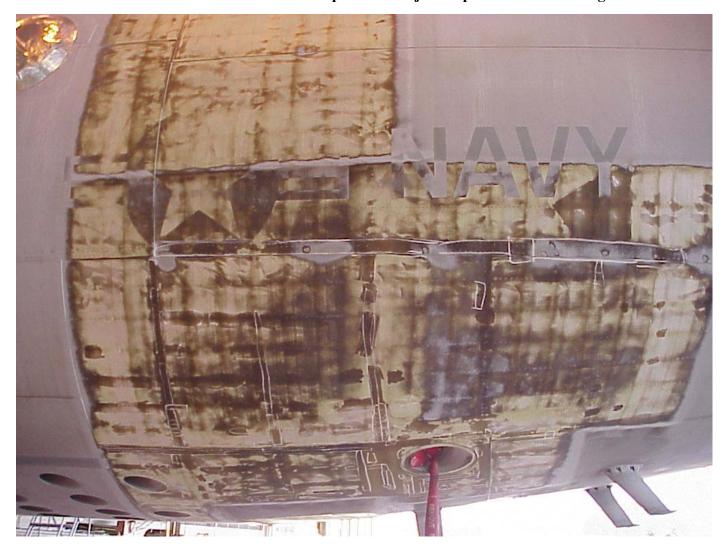
Mobile Fashjet® Phase III Demonstration Report Plate 16: Completed Flashjet Strip of Aft Port Fuselage

Note: (1) The above picture is a typical result of the flashjet® process over an aircraft which has been "seasoned" by field service repair. During demo the MFJ temperature control feature was set at 250F. Dark brown areas indicate thermally damaged conversion coat at the 250F setting. Lab panel test at right confirms thermal damage *(on right)* at temperature of 250F. (2) Identified chalked areas are the result of a corrosion inspection that identified these areas as positive for corrosion and will requiring glass bead blast to treat these corrosion sites. (3) The area around the lower right antennae is representative of the limit of FJ to reach/strip around obstructions but demonstrates FJ capability to "feather edge" strip areas into painted areas typically done by hand sanding.

- O The flashjet® process was found to thermally degrade the aircraft's chromate conversion coating in areas of in service repair for corrosion (See Plate 16). This deficiency necessitated that the damaged conversion coating be removed from these areas. Two available methods to remove this coating include (1) scotch brite cleaning [which was found to be labor intensive] or (2) use of chemical paint strippers. [Note, while the flashjet process was found to thermally degrade the aircraft's conversion coating, the metallurgical branch determined that the short time (approximately 1 sec) of thermal exposure at moderately low temperatures was not a concern with respect to substrate materials property effects.]

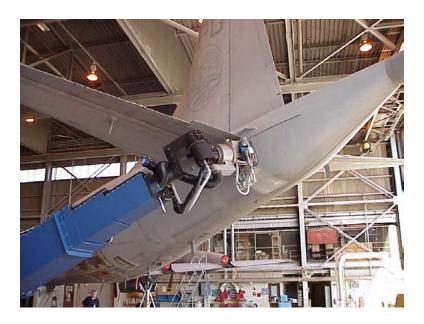
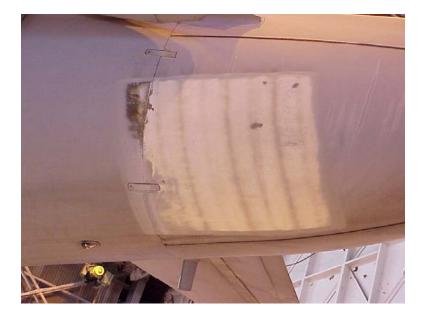
Mobile Fashjet® Phase III Demonstration Report Plate 17: Completed Strip of P-3 Composite Stinger

Notes: The flashjet strip process yields a uniform and damage free strip of P-3 (Honey-Comb Fiberglass) stinger. Materials lab subsequently recommends that epoxy and polyester fiber reinforced plastic (composite materials) structures/components should be considered for coating removal by FlashJet and that ideal candidate are those currently showing difficulty and damage with existing chemical, PMB or hand sanding depaint process methods.

5.7 Composite Strip Potential: As a final and very significant finding, the materials lab determined that the flashjet® technology was very effective at removing the surface coating of the polyester fiber reinforced plastic of the P-3 tail radome "stringer". (Refer to Plate 17.) See also MESR 03JX01532. Based on this data point, the materials lab recommended that the flashjet® process would be best suited for stripping composite surfaces such as the P-3 and EA-6B radomes, P-3 tail radome and other large composite aircraft surfaces and specifically those which exhibit difficulty and/or damage with existing chemical and/or PMB process methods. The materials lab further recommended that epoxy and polyester, fiber reinforced plastic (composite materials) structures and/or components should be considered suitable for coating removal by Flashjet® and that recurring problems with damage to such structures during coating removal with PMB, chemical and sanding processes could be significantly reduced or eliminated. It was noted, however, that Navair approval for subject composite surfaces is not available at this time and that specific NAVAIR approvals are needed before the flashjet® process could be fully employed in these instances.
